Manhole Inspection Summary

Manhole # S51K__017MH

Insp Date: **3/31/08 10:16 AM**

Location Address: **600 fleet st**

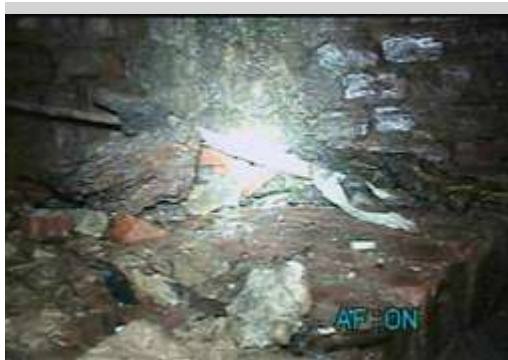
Defect 1

bench debris

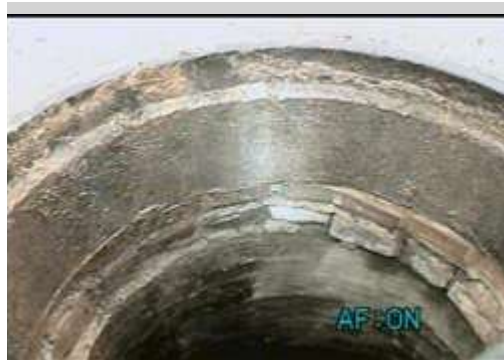
Defect 7

Condition: ☐ Sound ☐ Cracked ☐ Root Intrusion ☒ **Loose Brick** ☒ **Deteriorated**

chimney loose bricks, frame adjustment

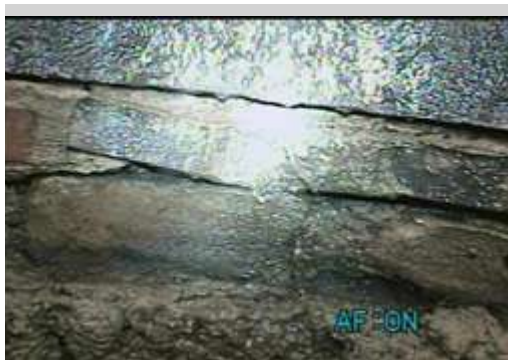
Defect 6

Infiltration: ☐ None ☒ **Joint** ☐ Cracks ☒ **Mortar** ☐ Roots ☐ Wall

infiltration from frame adjust ment & street level.

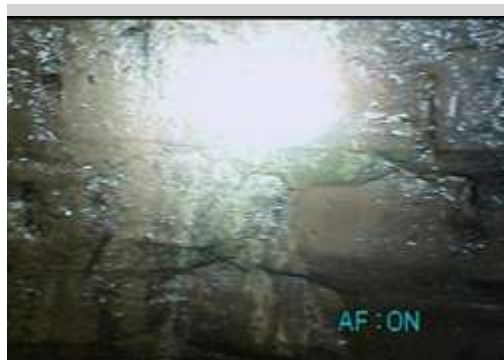
Defect 5

Infiltration: ☐ None ☐ Joint ☒ **Cracks** ☒ **Mortar** ☐ Roots ☒ **Wall**

cracks in barrel & infiltration

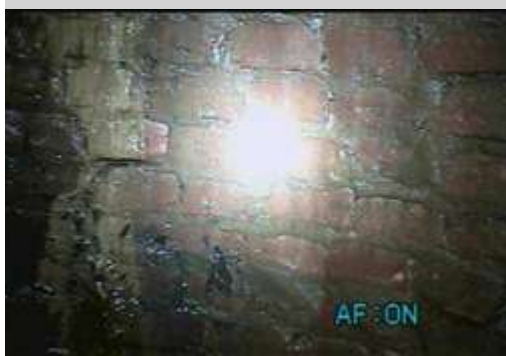
Defect 4

Condition: ☐ Sound ☒ **Cracked** ☐ Root Intrusion ☒ **Loose Brick** ☐ Deteriorated

cracked barrel

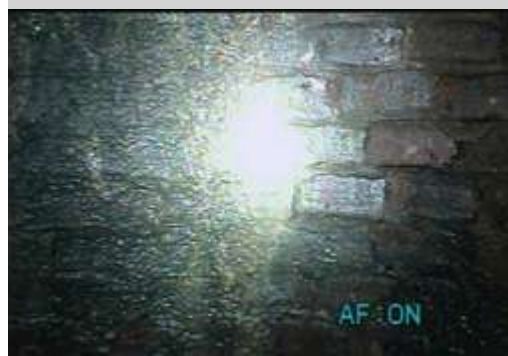
Defect 3

Infiltration: ☐ None ☐ Joint ☒ **Cracks** ☒ **Mortar** ☐ Roots ☐ Wall

corbel infiltration

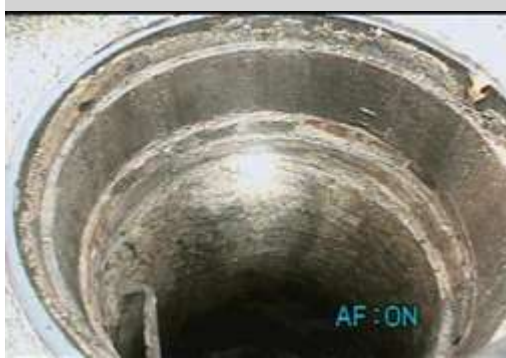
Defect 2

Frame Offset: **1** (in.) Condition: ☐ Sound ☐ Cracked ☒ **Leaks**

frame leaks, offset

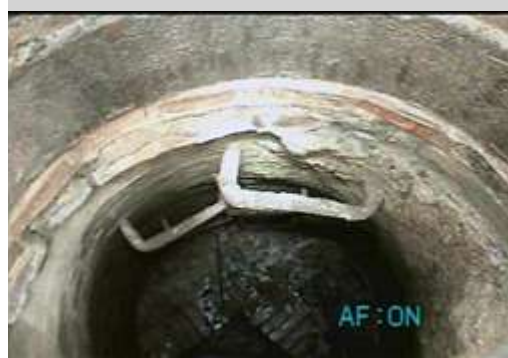
Steps Count: **5** Missing: **0** ☒ **Corroded**

steps

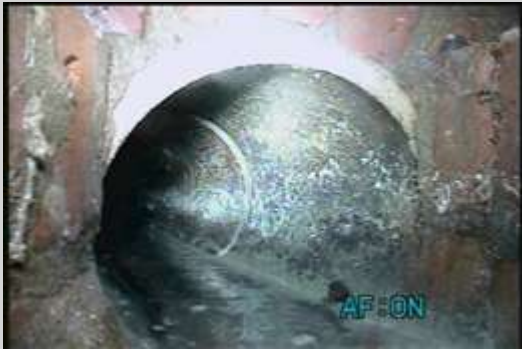
12 O'Clock Outflow

8 in. Circular Gravity Sewer
Pipe Out @ 12 O'Clock

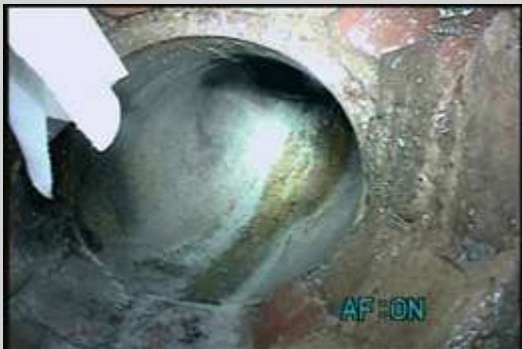
9 O'Clock Inflow

8 in. Circular Gravity Sewer
Pipe In @ 9 O'Clock
